Coal Burner Condition and Estimated Remaining Life Evaluation of Intermountain Power Project Units 1 & 2

Final Report

Coal Burner Condition and Estimated Remaining Life Evaluation - Intermountain Generating Station

August 15, 1990

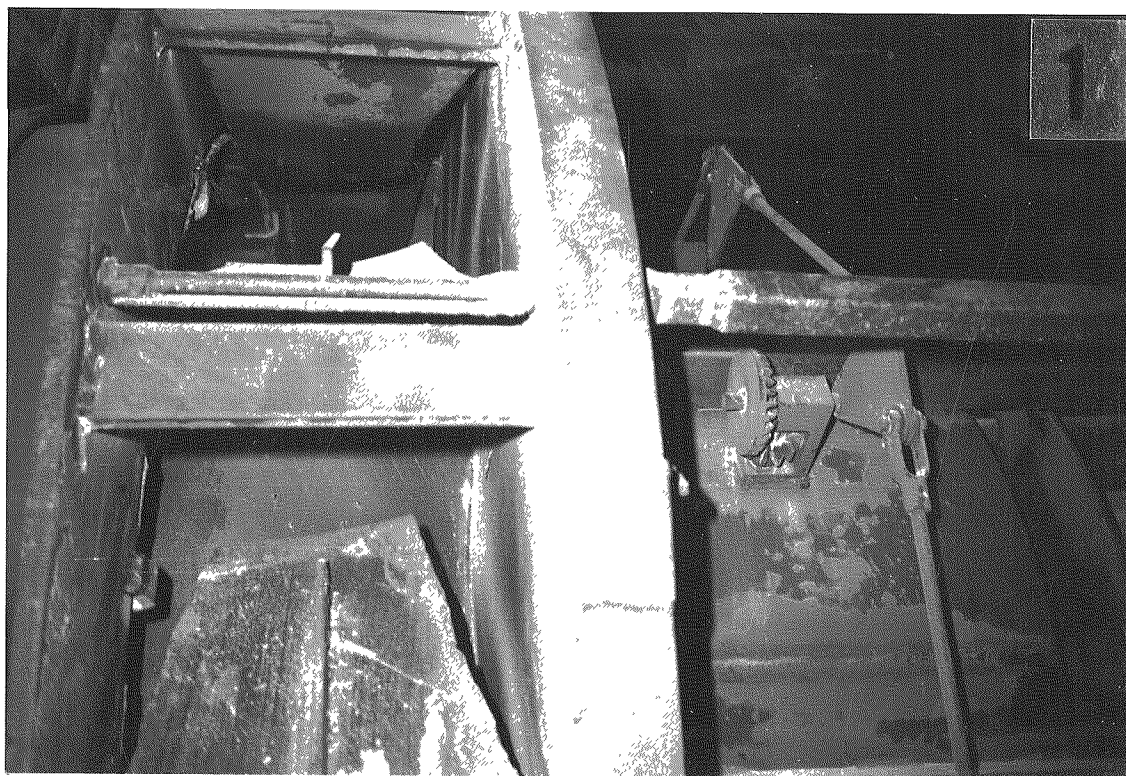
The general condition of the burners at this time is considered very poor. Numerous attempts to correct the problems have left the burners looking severely mistreated. All the register doors have been cut (Photos #1 & 2) to allow door movement due to register plates overheating and becoming severely warped. A triangular section has been removed along each door side that varies from one to two inches in width, and from the door tip to almost the door shaft in length.

Photo - Register door after major trimming.

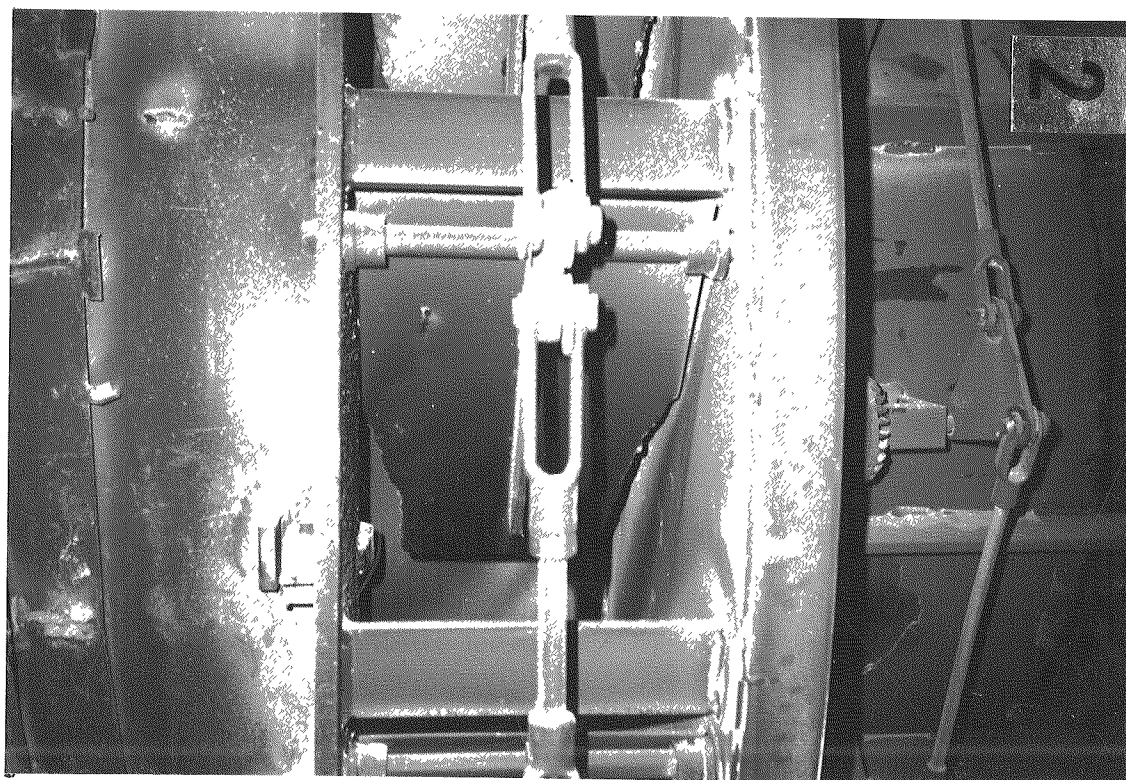
Photo 2 - Register door after major trimming.

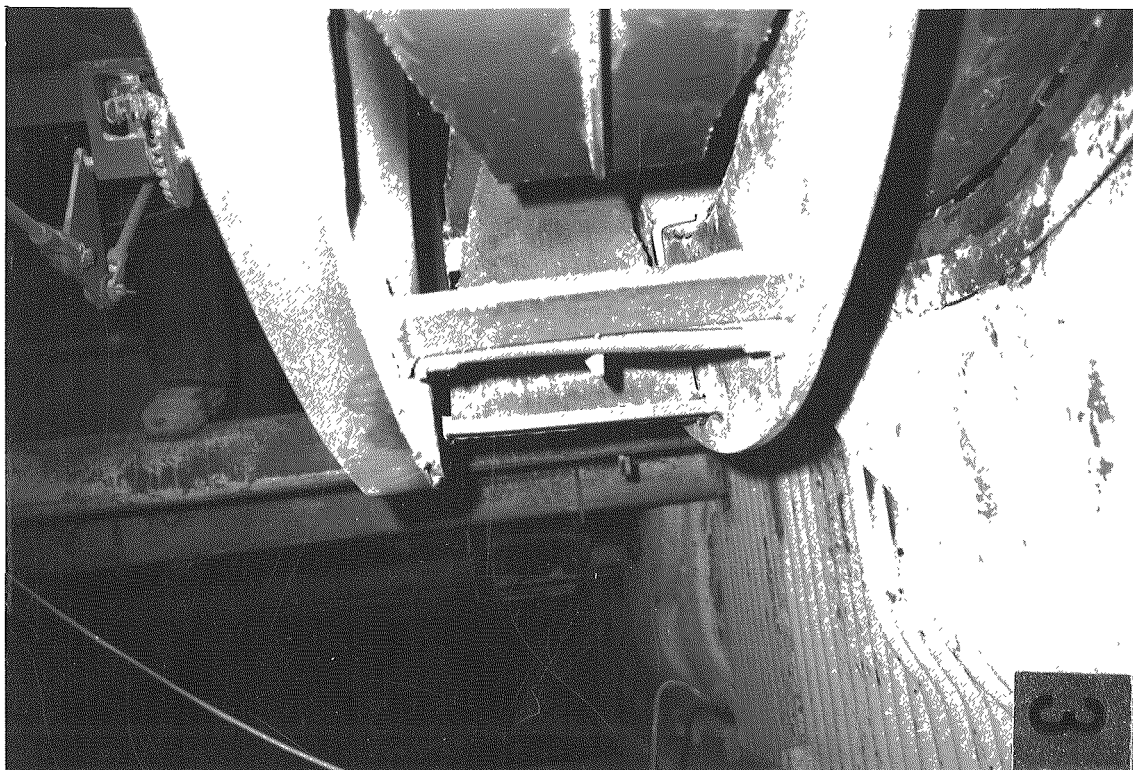
The physical appearance of the registers would indicate that adjustment while in service would be impossible for approximately 50% of the burners. The severity of the warped register plates and the bent door shafts create binding that prevents any adjustment. Register adjustment during the inspection was not allowed due to the fear that the register doors would not return to their original position. Only two sliding disks appeared to be impossible to operate. The remainder of the disks were free from any binding and appeared to be in good shape.

Photo 3 - Bent register door shafts.

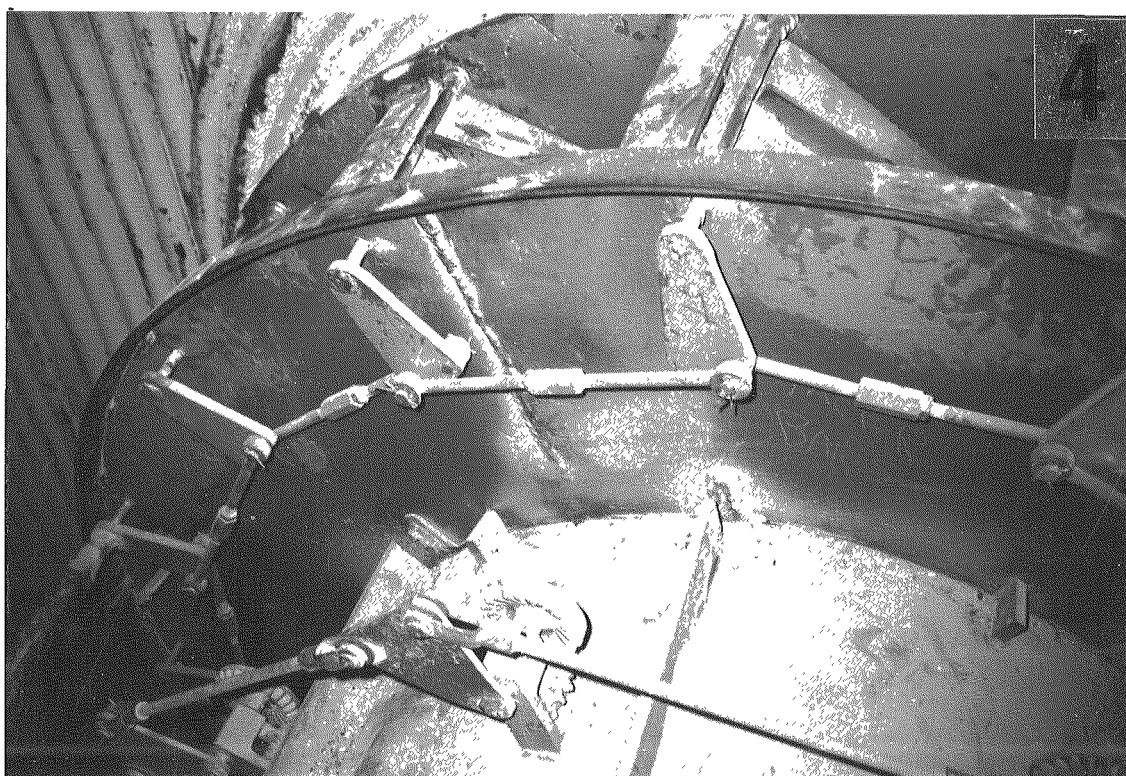
The outer air register assemblies have all been cut free from the inner air sleeve (Photo #4) so that these registers can move independently from the rest of the burner. The throat sleeve has also been cut free from the register front plate. Metal clips were installed in an attempt (Photos #5 & 6) to restrict the amount of movement between the throat sleeve and register front plate. The register is presently supported in only three locations. One is at the top of the inner sleeve, and the other two are supports from the register front plate (Photo #7) to the register support bracket. This support system promotes individual movement of the register plates which results in weld failures.

Photo 4 - Major welds were out to allow movement.

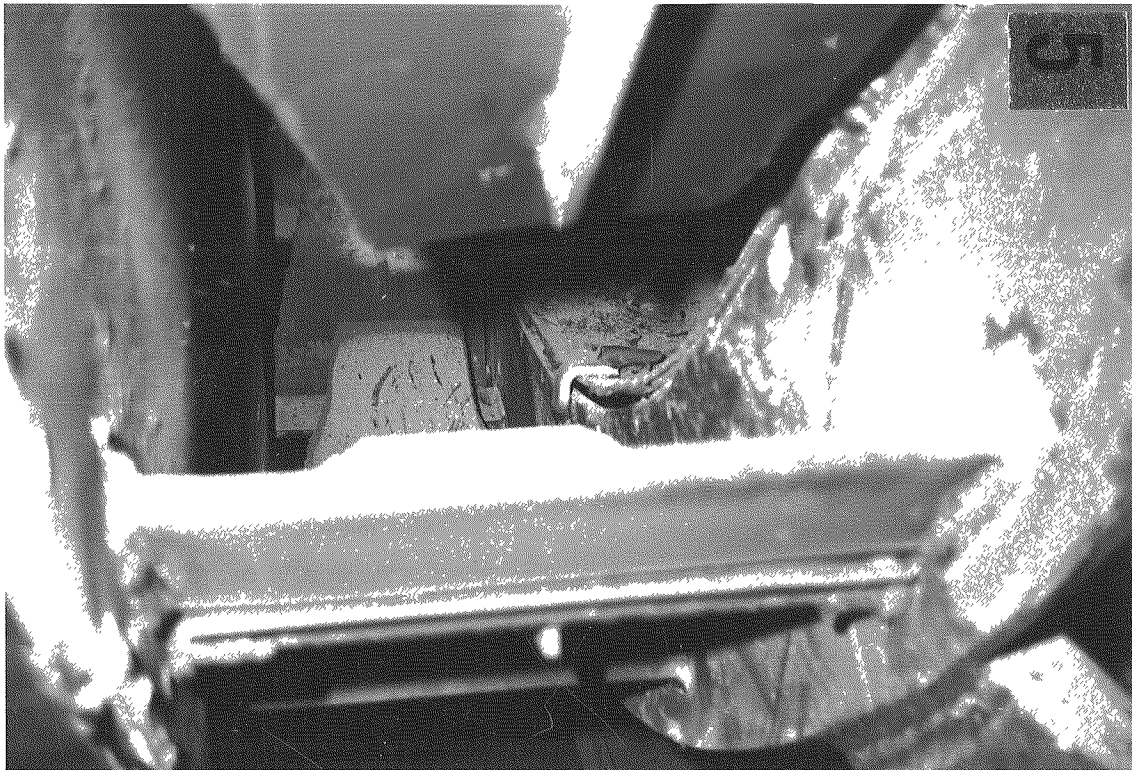
Photo 5 - Metal clips to limit movement of throat sleeve.

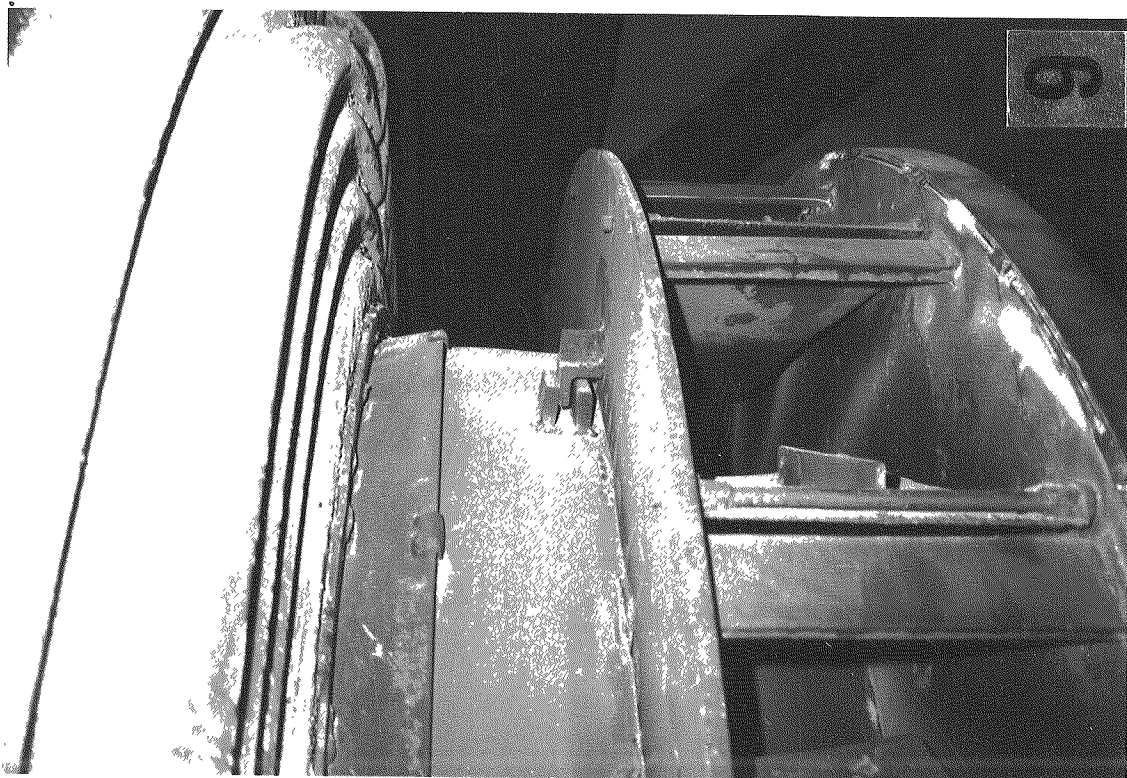
Photo 6 - Metal clips to limit movement of throat sleeve.

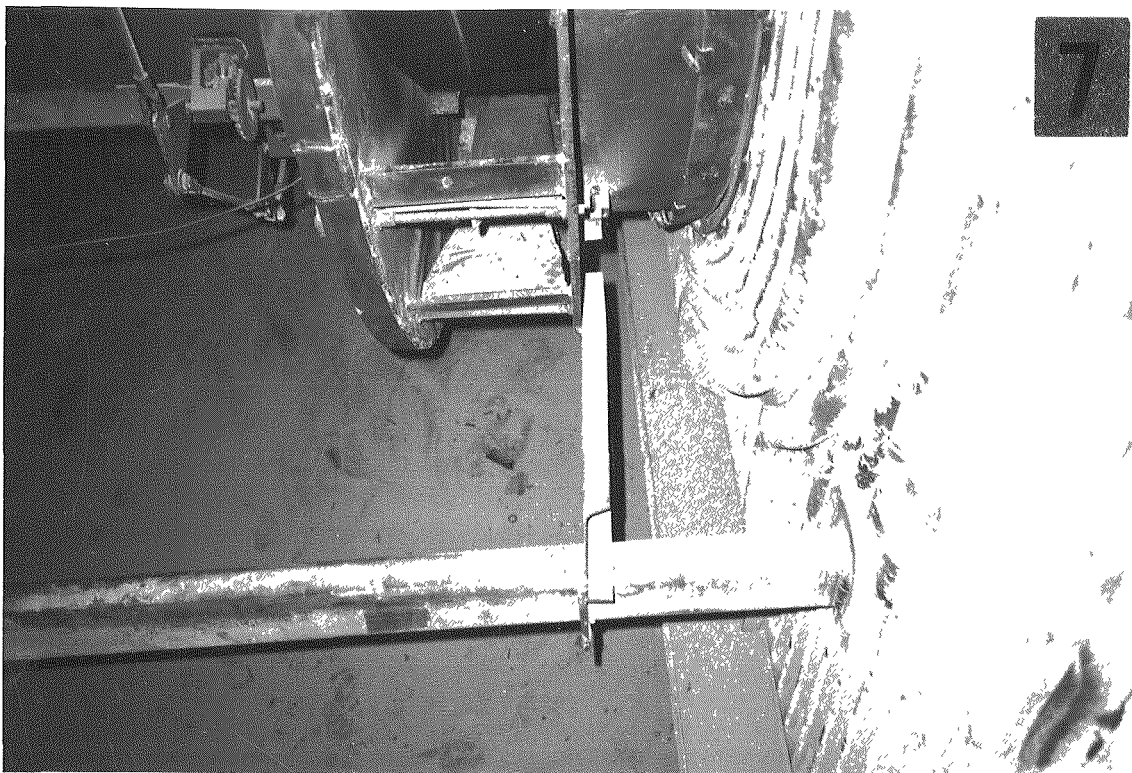
8. The support channel connecting the register front plate to the register support bracket was bent (Photo #7) and unable to slide freely on ten burners. This was caused by insufficient clearance between the retainer and register support bracket. The bending of the support channel distributes additional stresses to the register front plate which enhances the warpage of that plate.

Photo 7 - Bent and bound register support bracket.

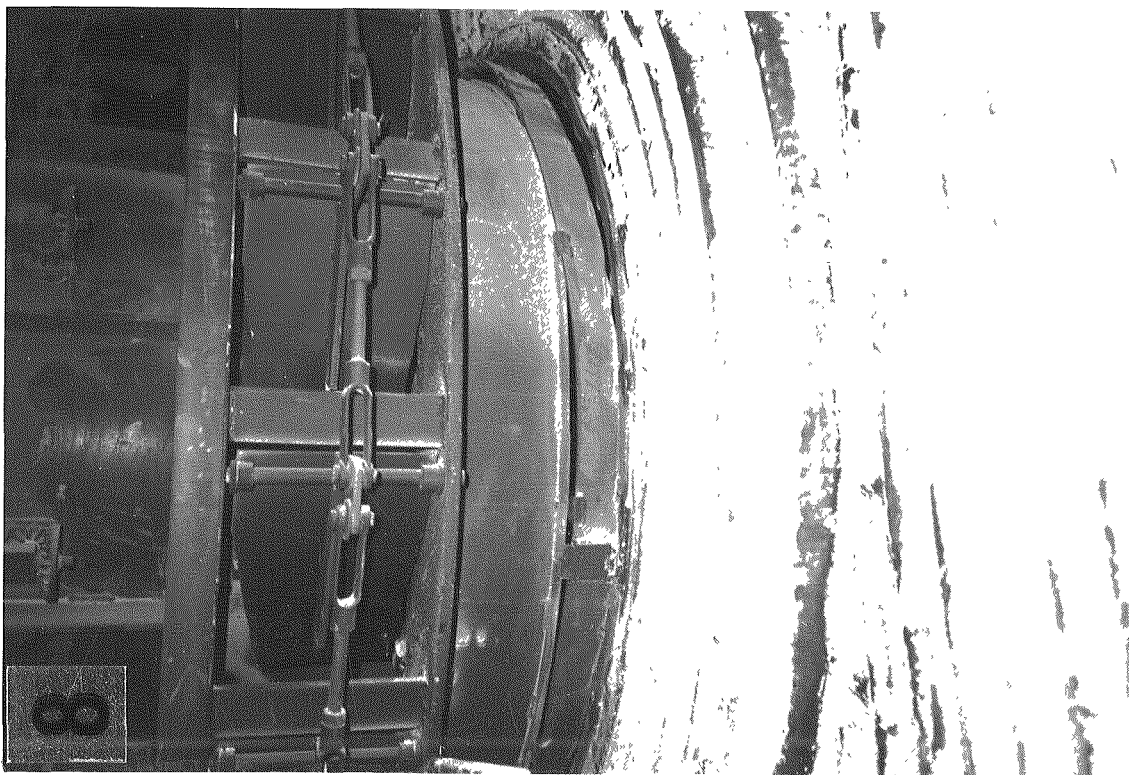
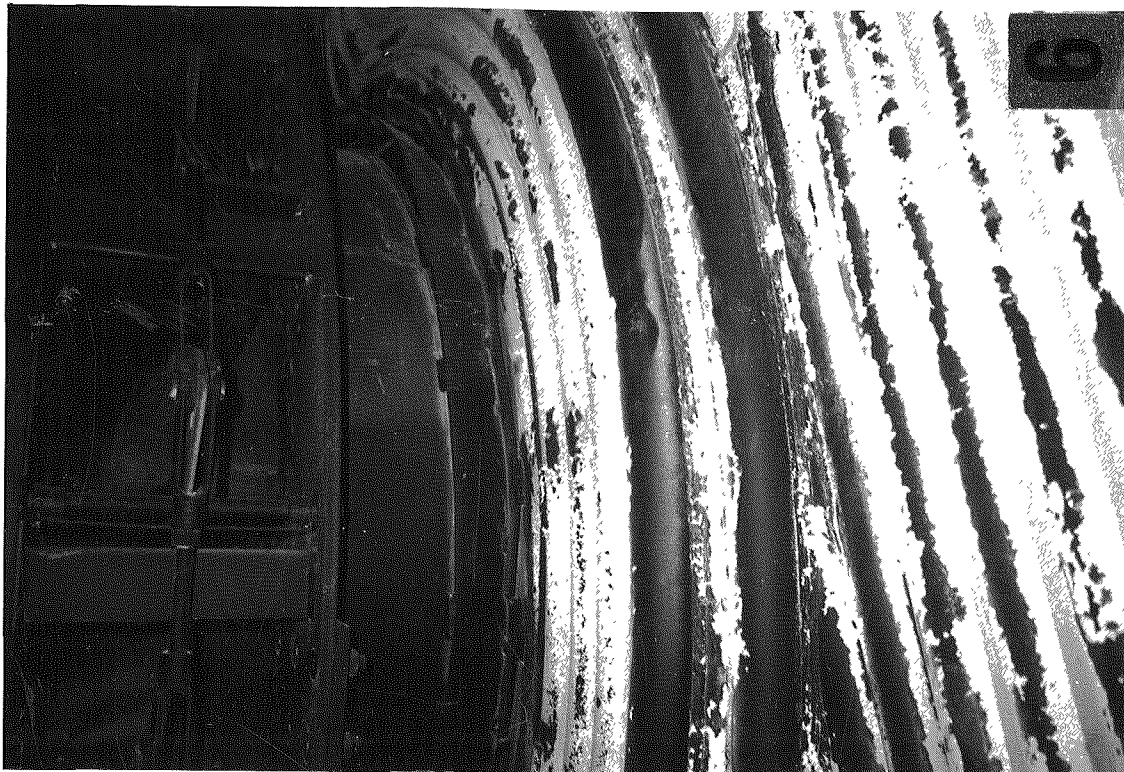
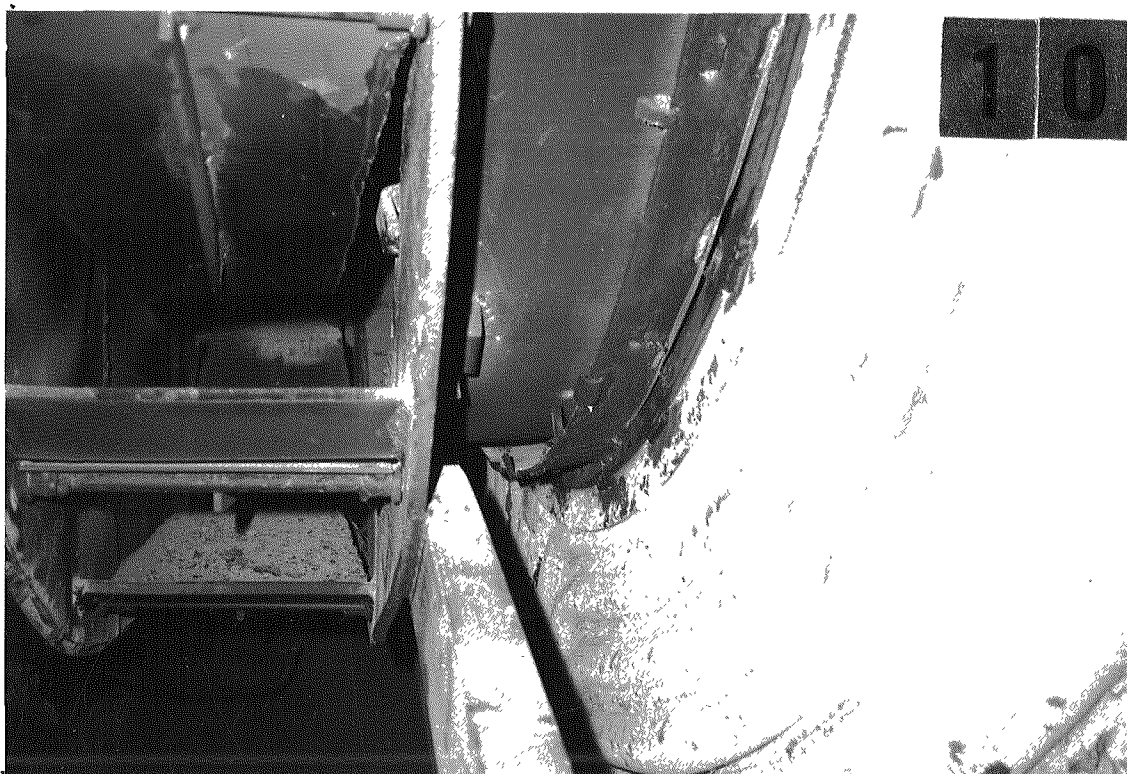
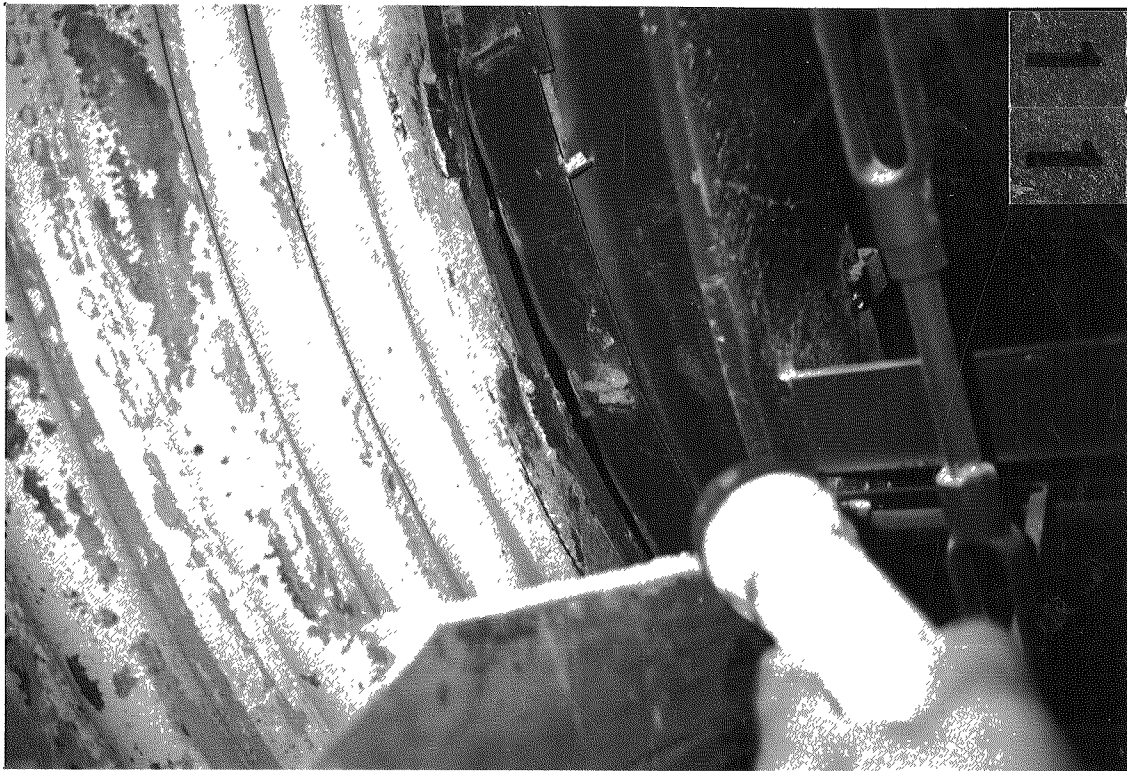
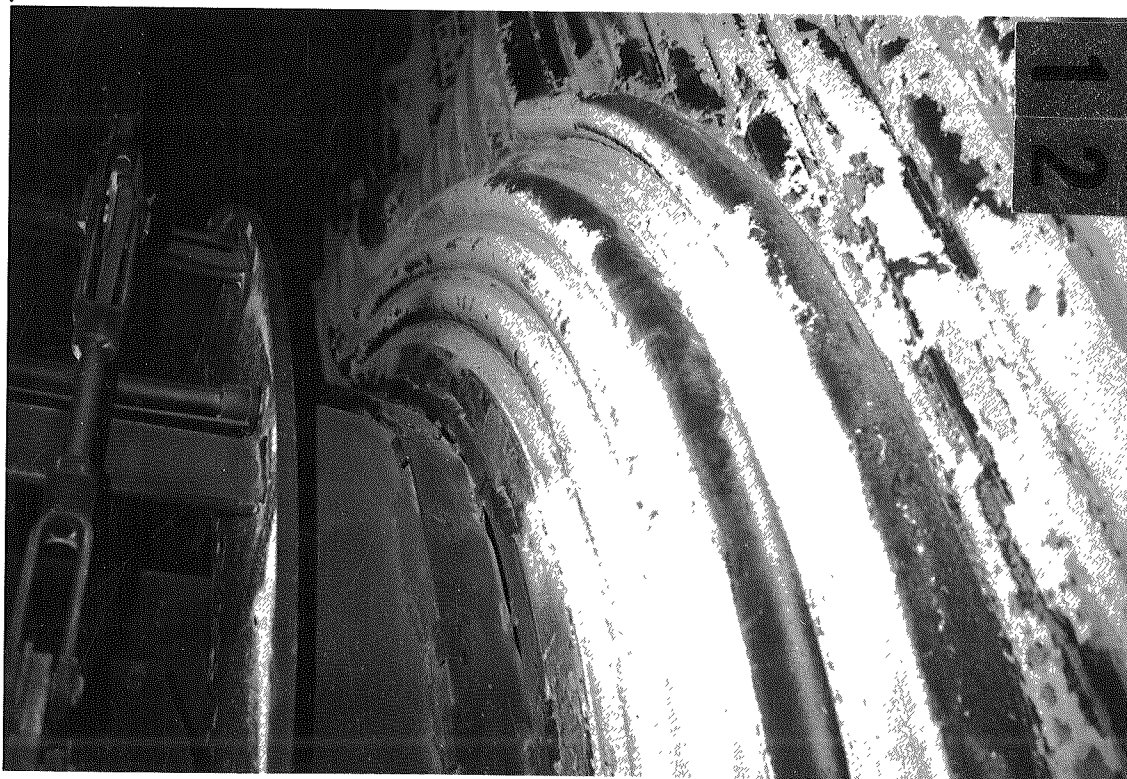
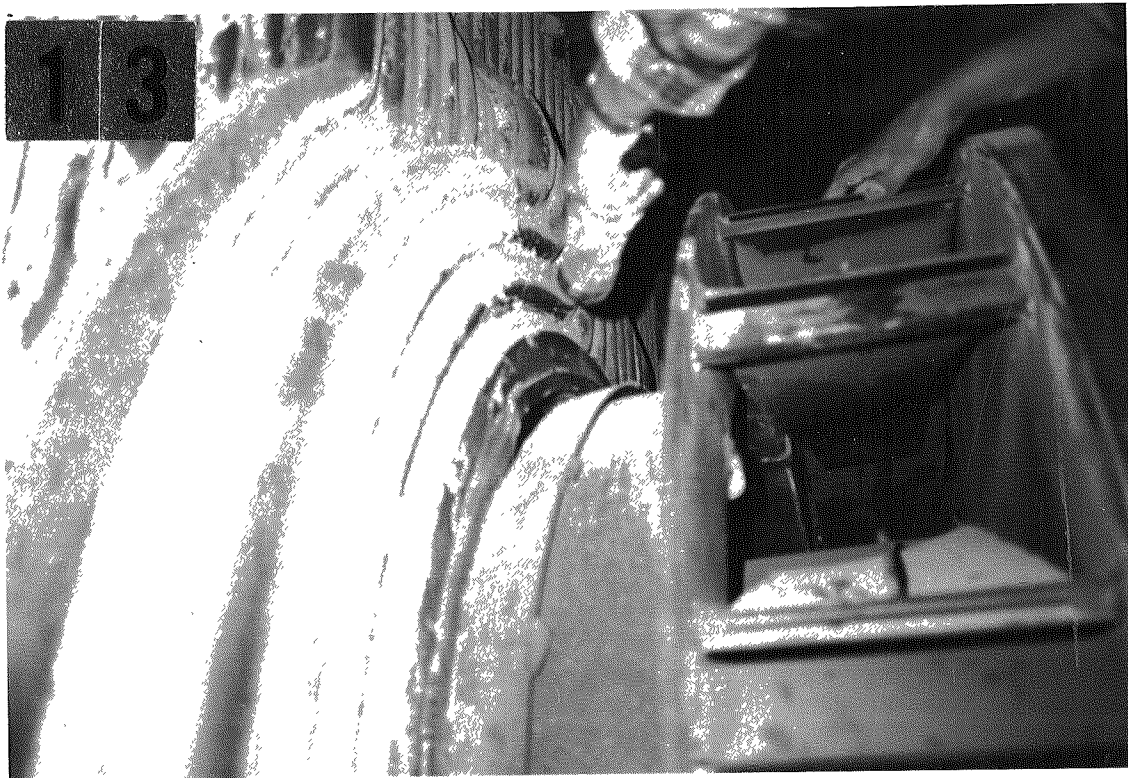
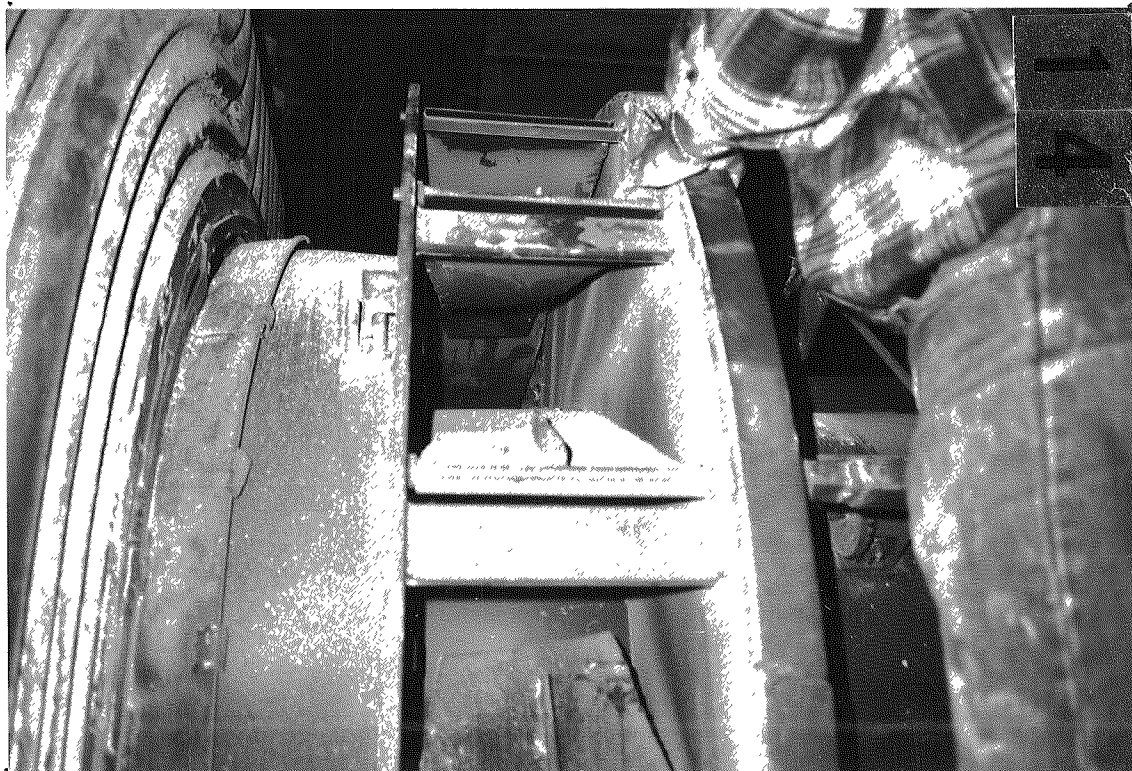
9. The throat sleeve and the throat sleeve casing on all forty-eight burners needed repair or replacement. B & W Construction was making these repairs during the burner inspections. The rope seal packing was virtually non-existent. This was allowing large quantities of air to escape into the furnace without flowing through the burner. Also, approximately 90% of the welds connecting the throat sleeve casing to the furnace wall (Photos #8 - 10) were broken. The casing was free to move in any direction and this caused large gaps (1-2 inches) for air leakage into the furnace. A conservative 1" gap around the burner would amount to 6.9% of the throat area.

Photo 8 - Broken welds and warpage of the throat sleeve and throat sleeve casing

Photo 9 - Broken welds and warpage of the throat sleeve and throat sleeve casing.

Photo 10 - Broken welds and warpage of the throat sleeve and throat sleeve casing.

Photo 11 - Broken welds and warpage of the throat sleeve and throat sleeve casing.

Photo 12 - Broken welds and warpage of the throat sleeve and throat sleeve casing

Photo 13 - Broken welds and warpage of the throat sleeve and throat sleeve casing.

Photo 14 - Broken welds and warpage of the throat sleeve and throat sleeve casing.

B&W field service and construction personnel were on site during the one week outage when the burners were inspected. They were replacing the slip seal casing on all 48 burners on Unit 1. These casings have been repaired or replaced on previous outages. Several (4-8) small gusset plates were being welded on the outside of the casing in an attempt to hold the casing in place. The previous casing was welded directly to the tube wall. The casing would expand from thermal expansion (1/2-5/8" on the diameter) but was limited until it broke the welds. During this time the free end of the casing would expand and the casing would resemble a 45° cone. The packing would fall out and large gaps (1-2") would appear. This new installation is at best a short term replacement, because the problem of thermal expansion is not being addressed properly. By restricting the movement, large stresses will result or the welds will break again.

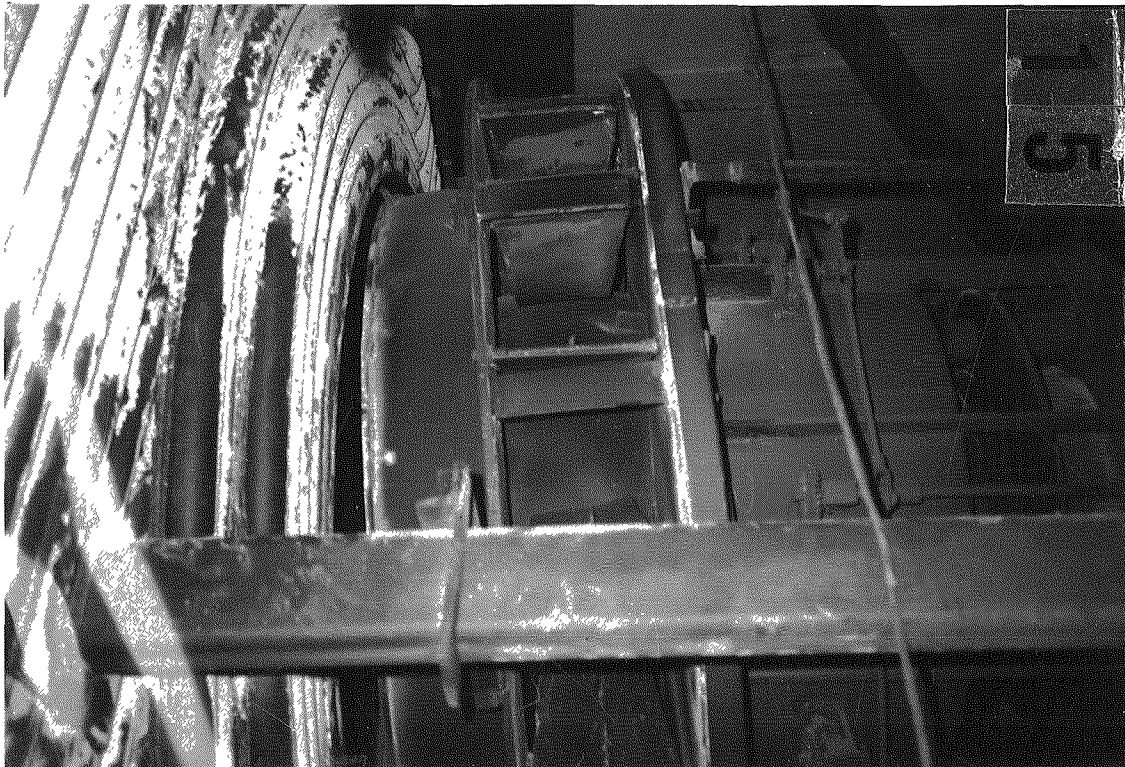
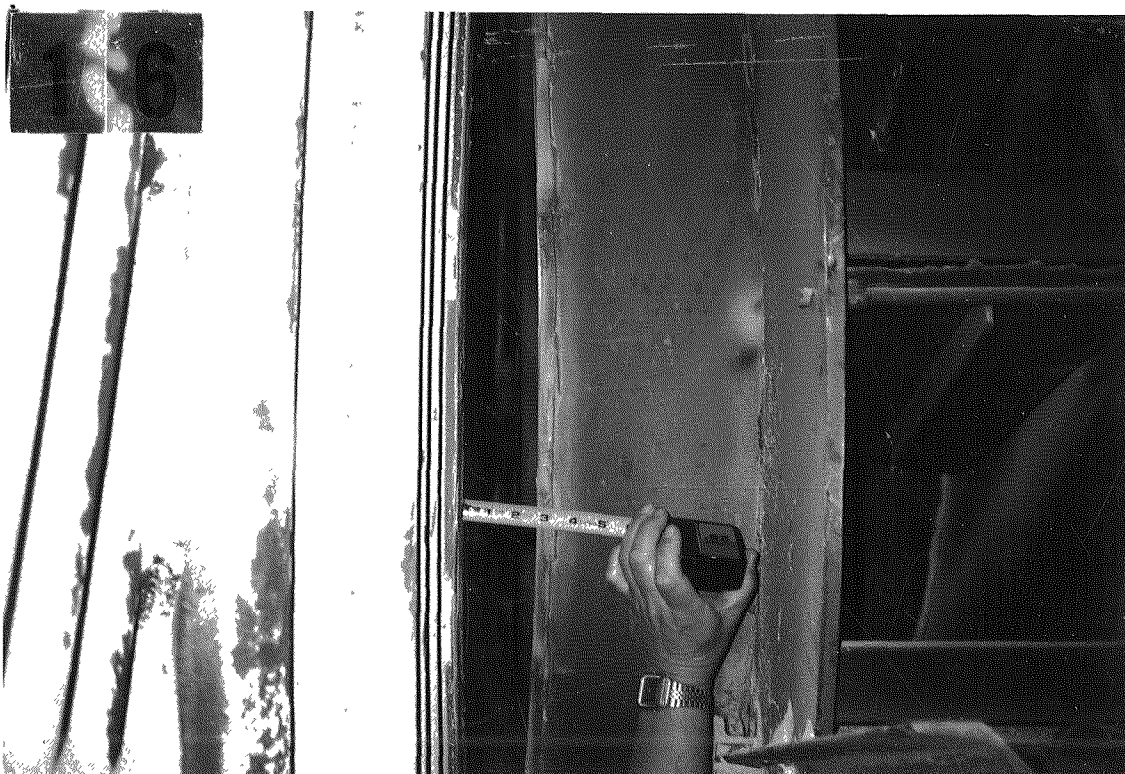
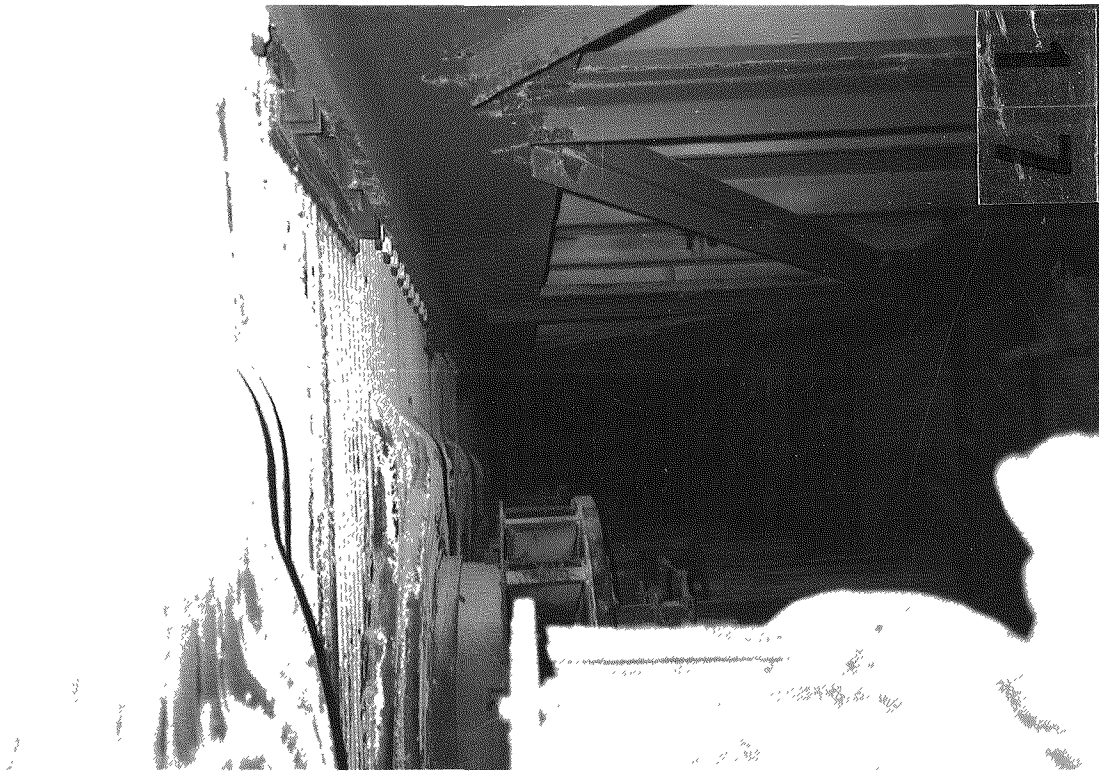
5. The burner register or the throat sleeve was misaligned with the bent tube opening of the waterwall (Photos #15-17) on eleven burners due to warpage.

Photo 15 - Misalignment of throat sleeve and waterwall opening.

Photo 16 - Misalignment of throat sleeve and waterwall opening.

Photo 17 - Misalignment of throat sleeve and waterwall opening.

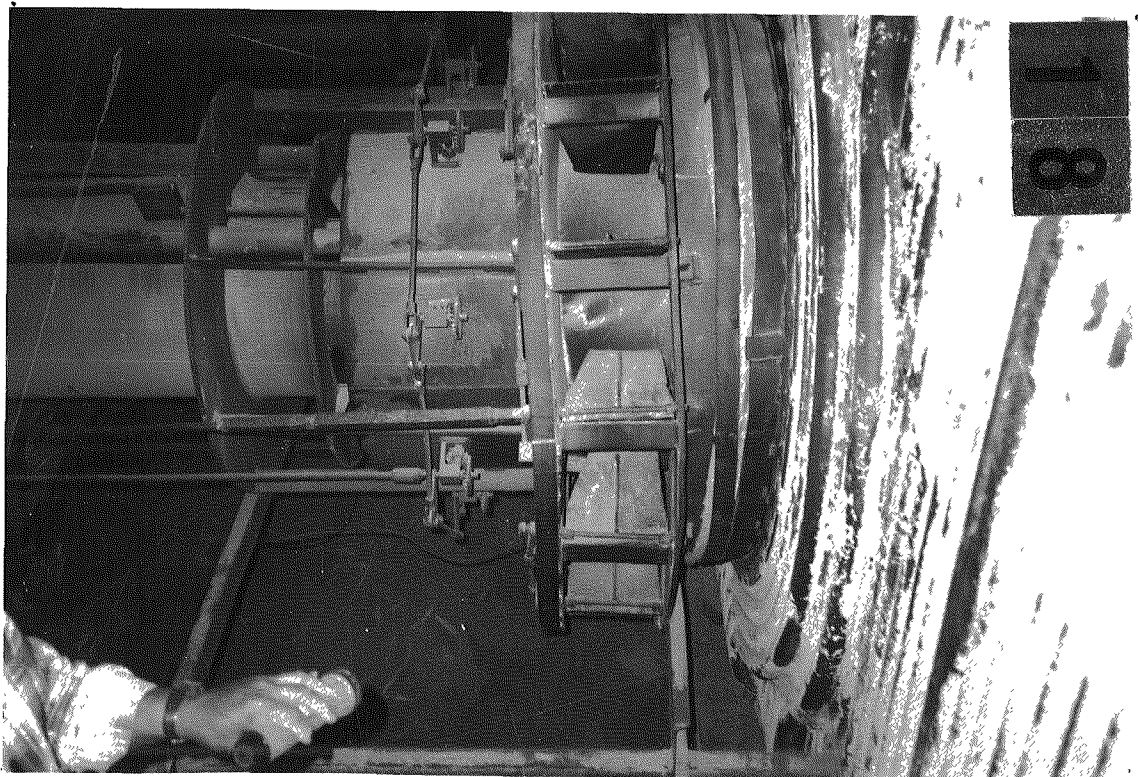
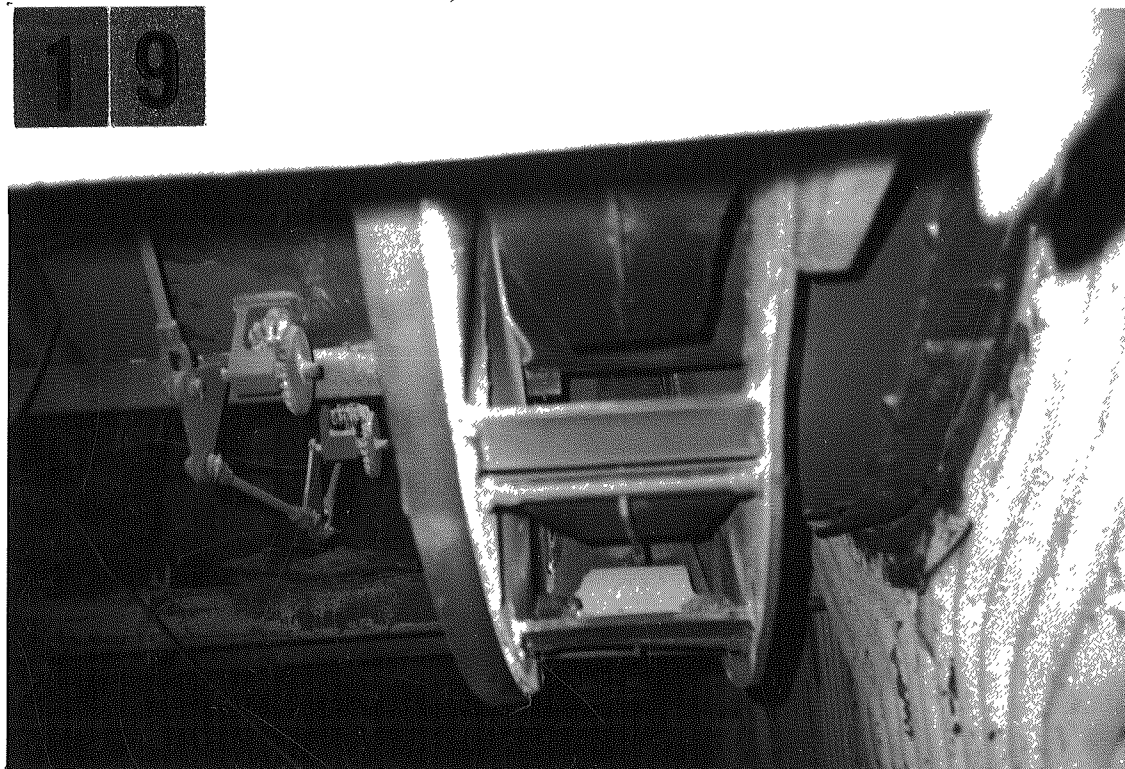
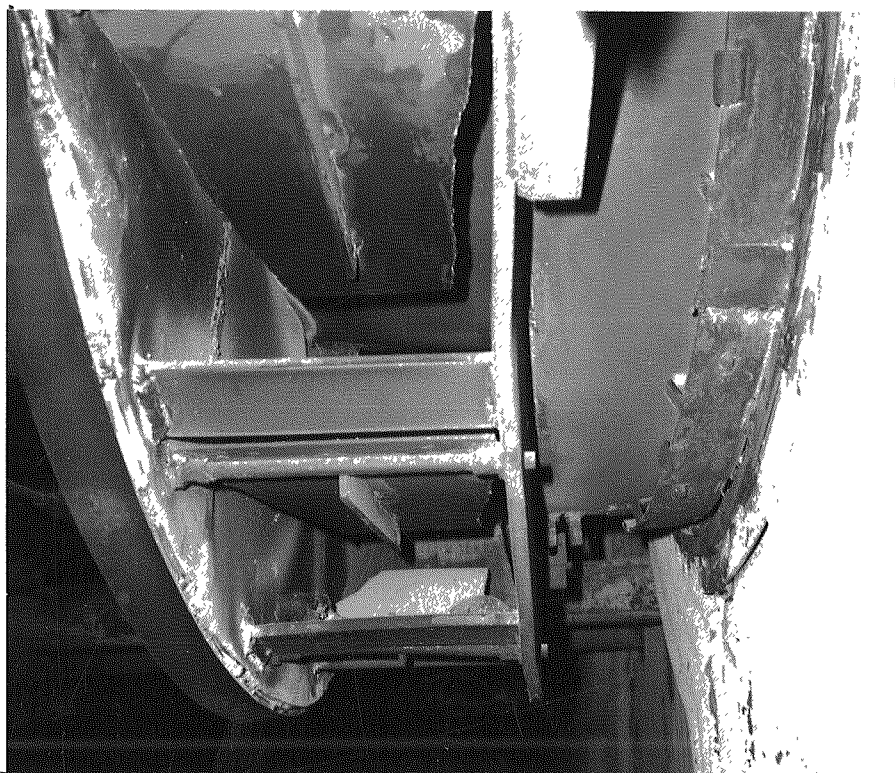
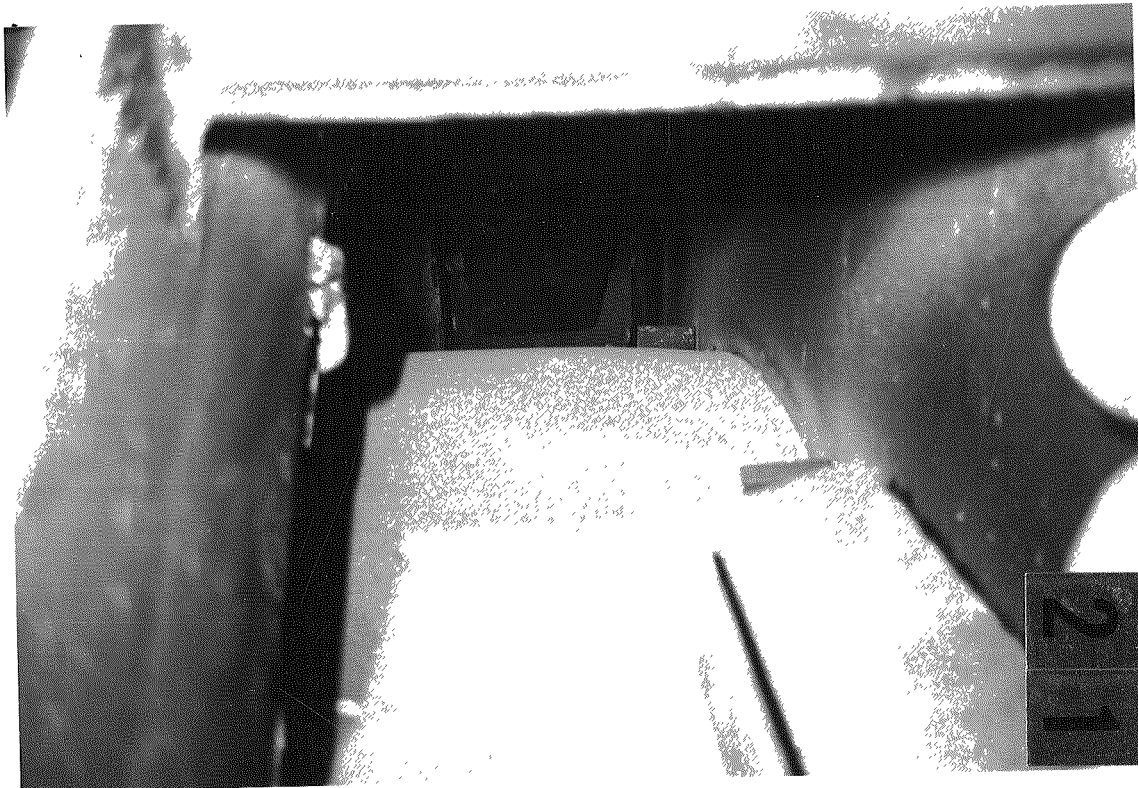
3. The register rear plate was warped (varied from 1/2" to 1") on twenty-six burners (Photos #22 & 23).
4. The register front plate was warped (Photos #18-21) on fourteen burners.

Photo 18 - Warped front register plate.

Photo 19 - Warped front register plate.

Photo 20 - Warped front register plate.

Photo 21 - Warped front register plate.

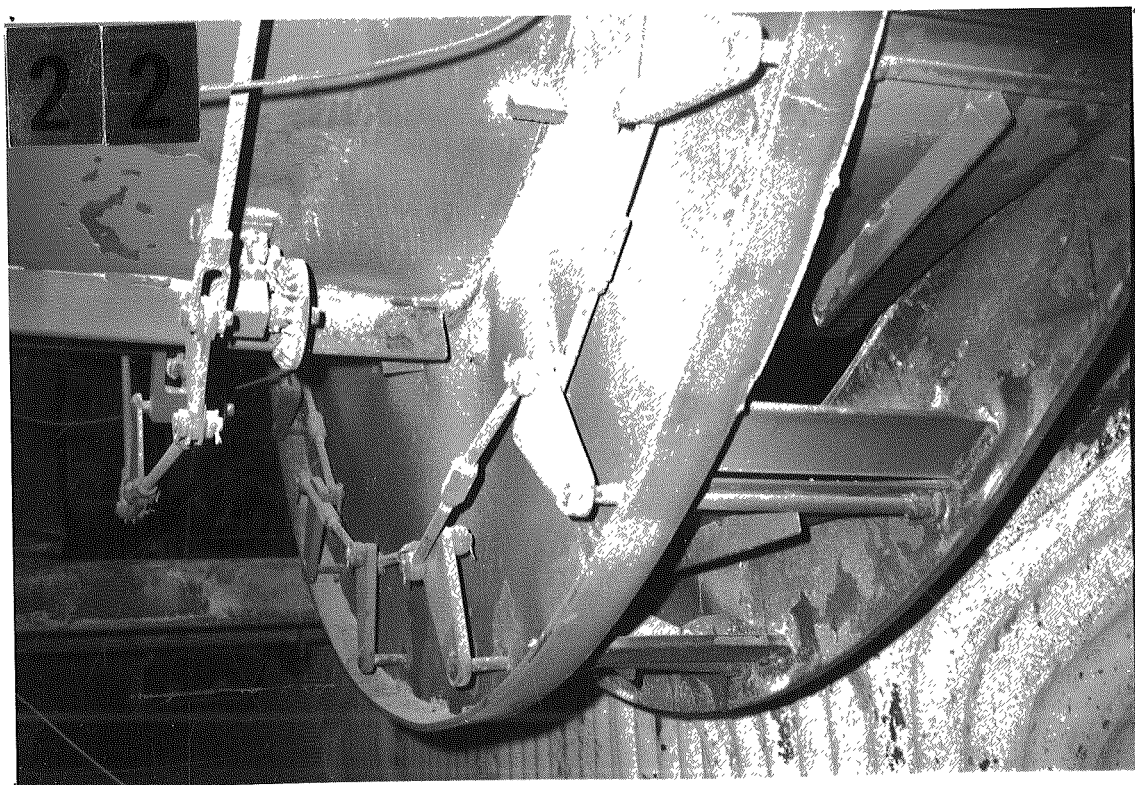
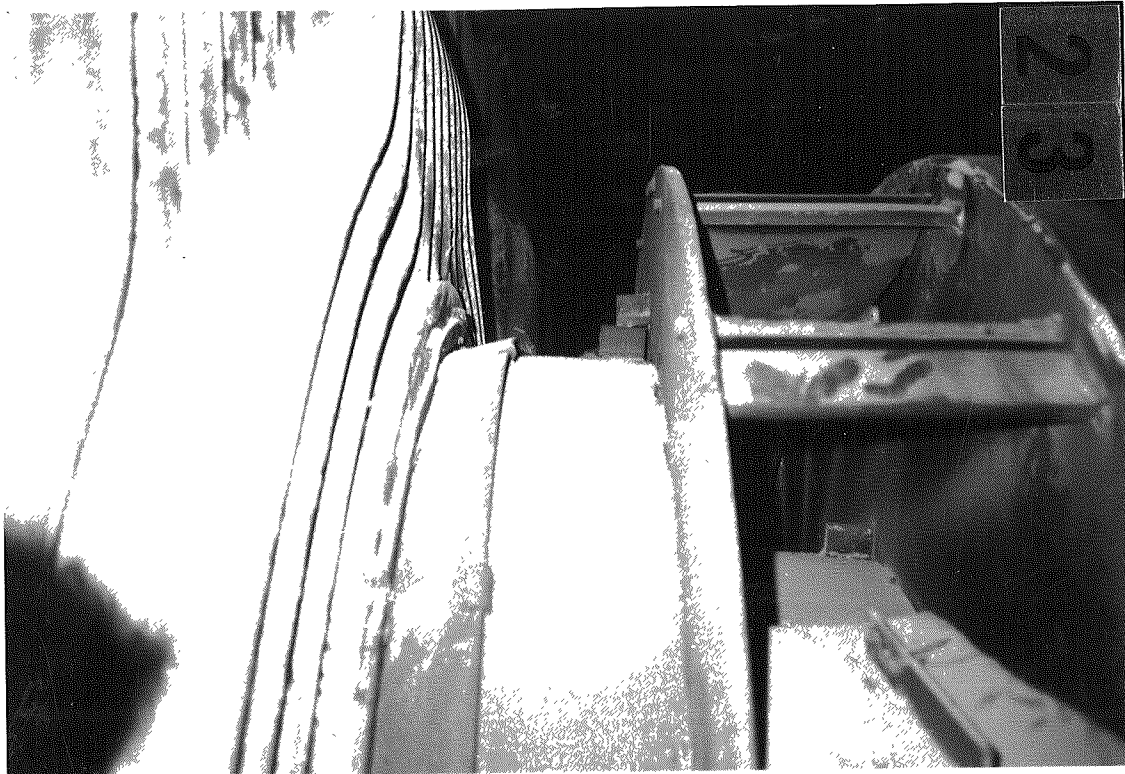
Photo 22 - Warped rear register plate.

Photo 23 - Warped rear register plate.
